## STS-104 FLIGHT READINESS REVIEW

# BACKUP INFORMATION

# STS-98 IN-FLIGHT ANOMALIES BACKUP

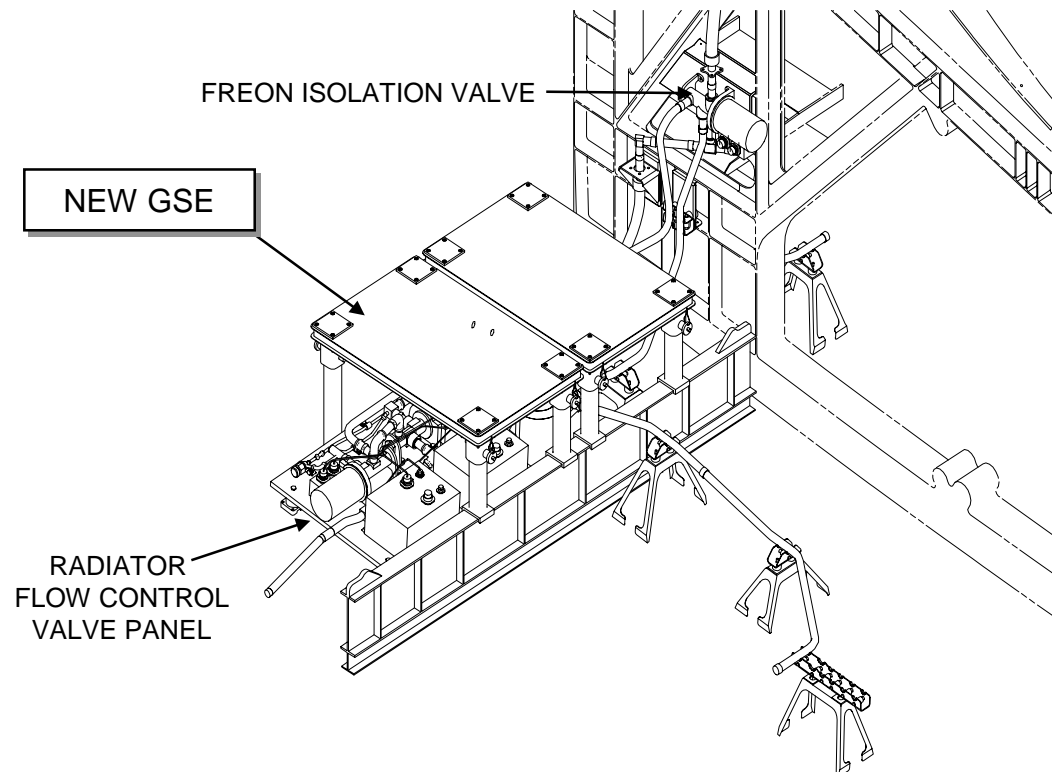
## First Flight of MCR 17177 Freon Relief Line Reroute

- GSE developed to protect exposed relief lines for systems which have not yet been modified

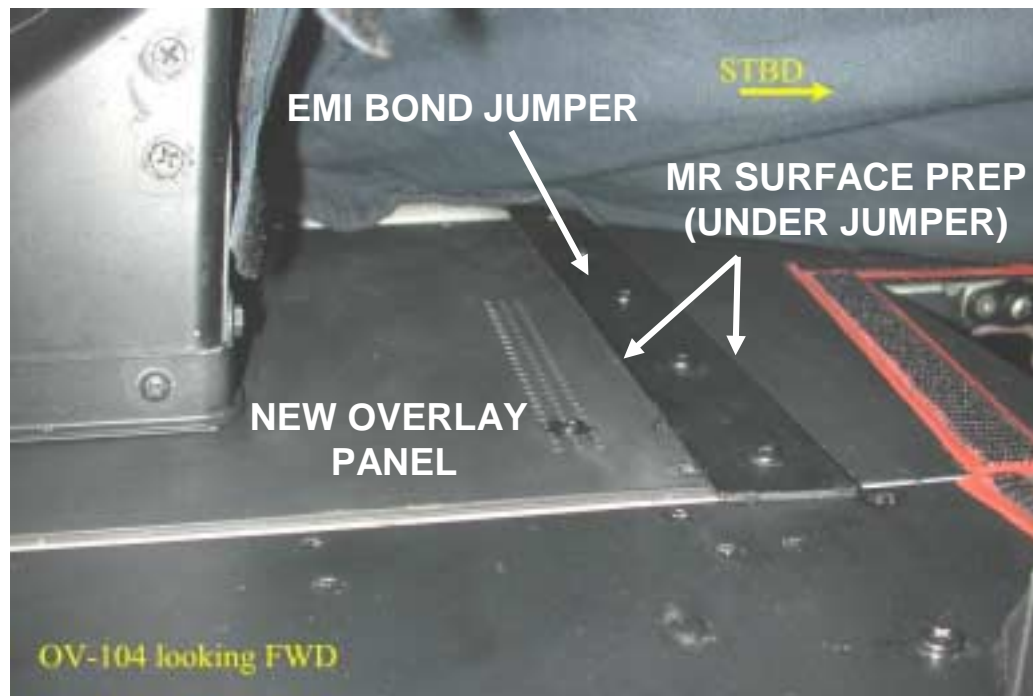
### MCR 23021 MEDS Panels

- MR required to resolve non-compliance with lightning protection surface preparation

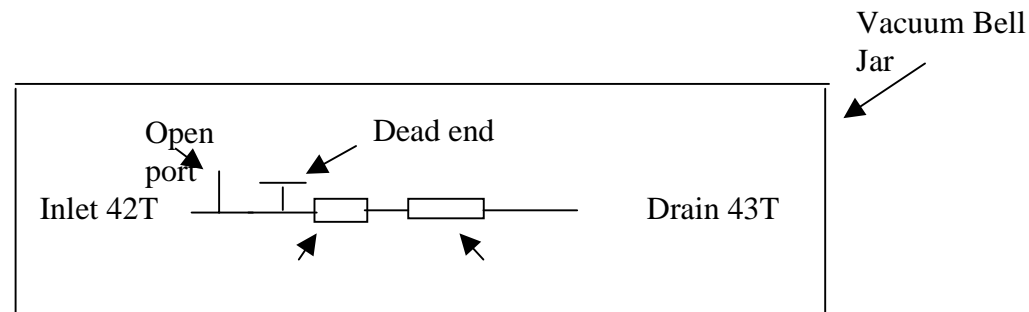
### NSLD vacuum burp test:

- NSLD testing is being performed on skid to further characterize contamination process
- Part 2 is to determine level after use of vacuum pump.
- Results:
  - No vacuum oil was deposited on clean hardware
  - Singular event deposits evaluated by turning off pump power to aid oil back diffusion
  - Singular event would be associated with processing of 12" pre-valve (11/92, 3/99, 6/99, 3/01)
    - Only time vacuum system is open to LN2 system
